Graymills

COUPLING REPLACEMENT INSTRUCTION FOR QD SERIES 795-90455

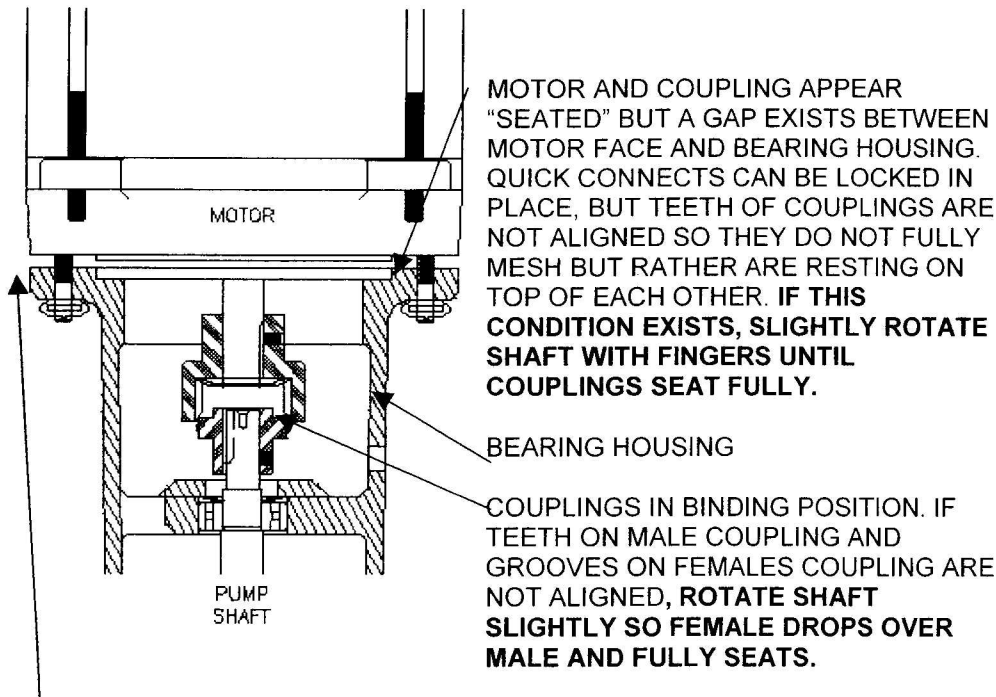
1. IMPROPER SEATING/MESHING OF THE MOTOR AND BEARING HOUSING COUPLINGS

MOTOR NOT SEATED COMPLETELY BECAUSE TEETH ARE MISALIGNED.

MOTOR AND BEARING HOUSING SHOULD BE IN CONTACT-NO GAP

COUPLINGS IN BINDING POSITION. IF TEETH ON MALE COUPLING AND GROOVES ON FEMALES COUPLING ARE NOT ALIGNED, ROTATE SHAFT SLIGHTLY SO FEMALE DROPS OVER MALE AND FULLY SEATS.

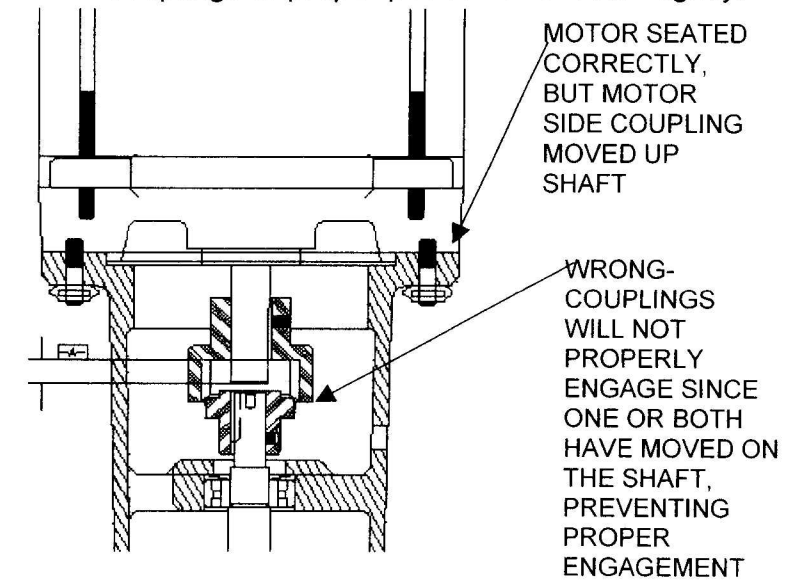
2. COUPLINGS HAVE MOVED ON THE SHAFT-

This usually happens when the couplings don't mesh correctly and the motor is forced down.

Move couplings to proper position and fasten tightly.
